Test Report

ANSI/CAN/UL-2272, Electrical Systems for Personal E-Mobility Devices

Name of Products: Crazy cart

Report No. PNS220517152 01001

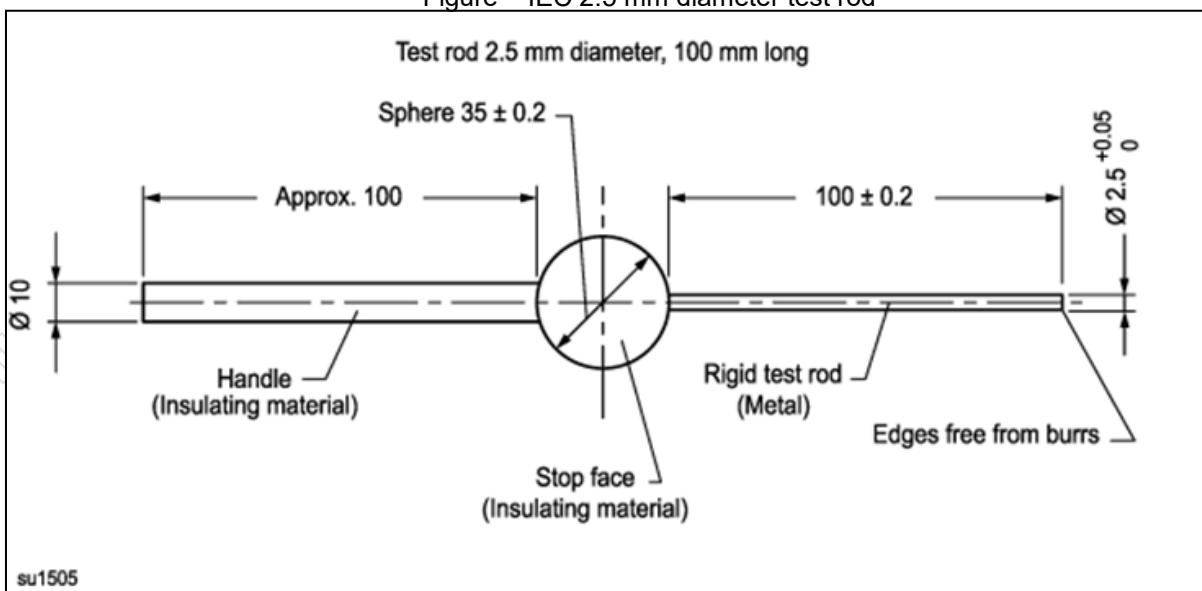
The sample was examined with the probe of 9.1.3 to determine if it was possible to access hazardous parts if applicable.

Figure – IEC 2.5 mm diameter test rod

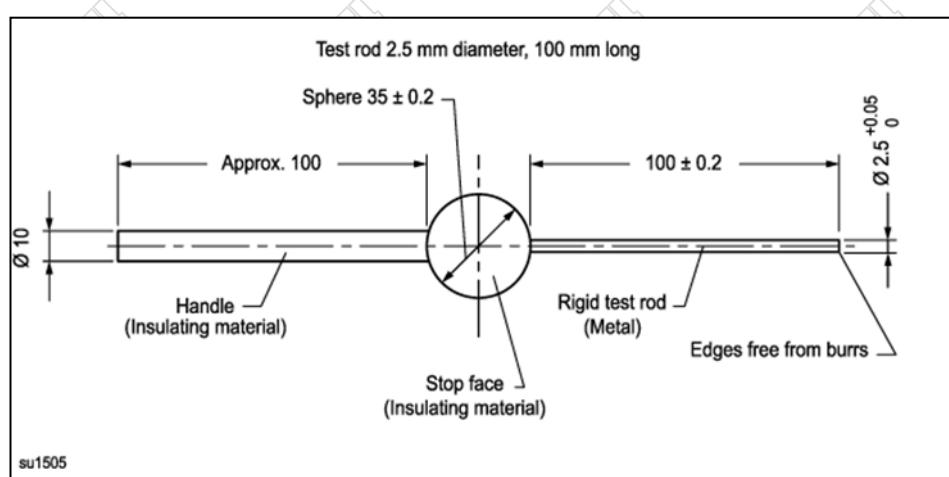
Figure - IEC 2.5 mm test rod

Note: The handle dimensions ($\varnothing 10$ and 20) are not critical.

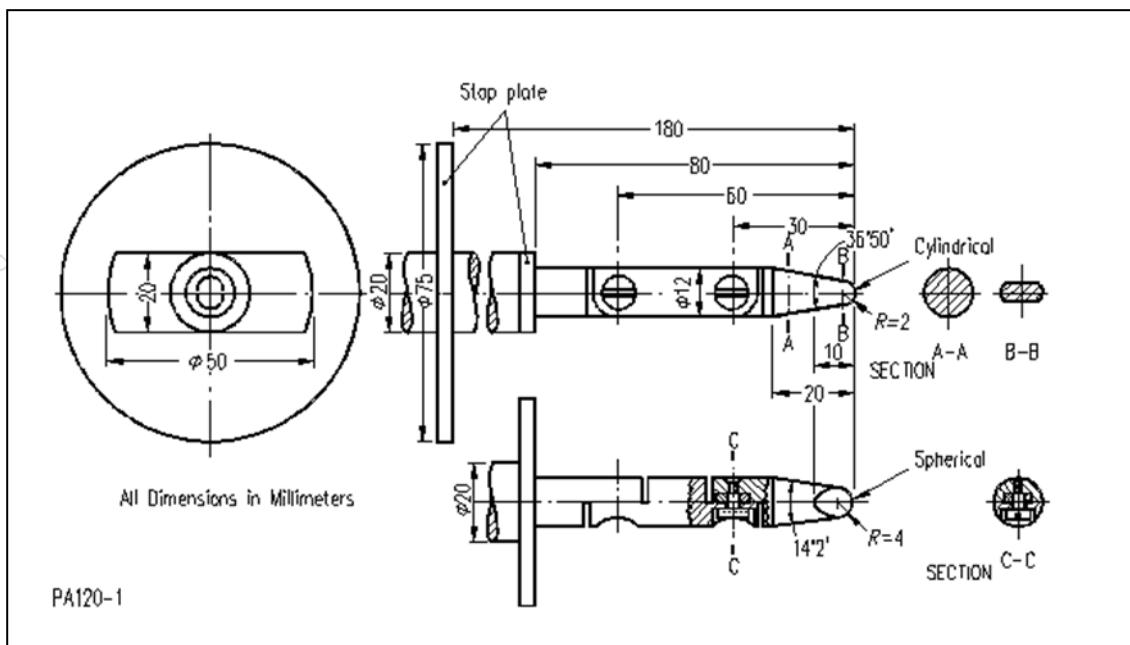
Figure - Articulate probe

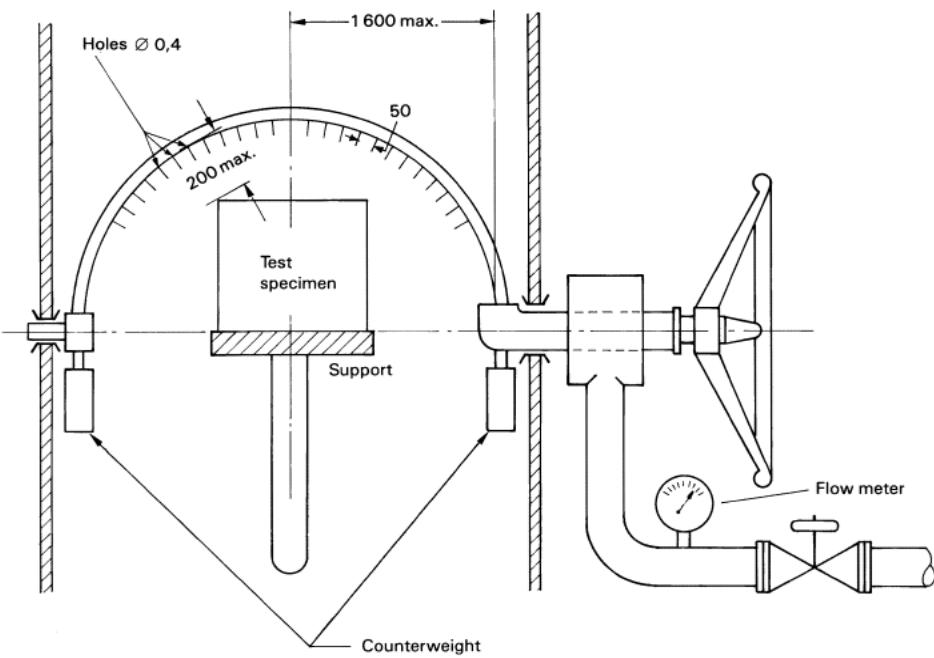
a) Conditions when using the test device of figure 4 (oscillating tube):

The oscillating tube had spray holes over the whole 180° of the semicircle. The total flow rate was adjusted as specified in the above table and was measured with a flow meter. The tube oscillated through an angle of almost 360°, 180° on either side of the vertical, the time for one complete oscillation (2 × 360°) was about 12 s. The duration of the test was 10 min. The support for the DUT was perforated to prevent it from acting as a baffle, and the DUT was sprayed from every direction by oscillating the tube to the limit of its travel in each direction.

Dimensions in millimetres

NOTE The range of holes is shown as for second characteristic numeral 3 (see 14.2.3 a)).

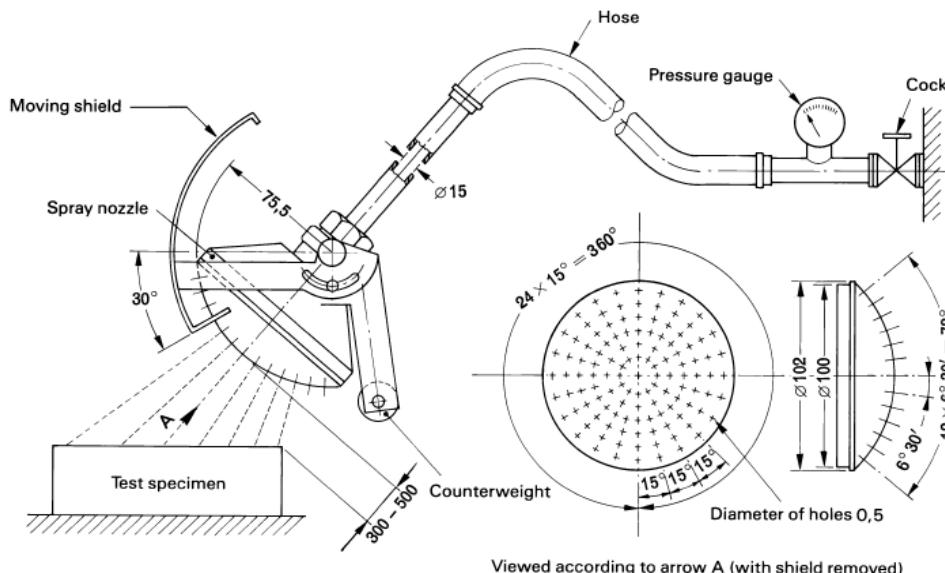
b) Conditions when using the test device as in figure 5 (spray nozzle): The counterbalanced shield was removed from the spray nozzle and the enclosure was sprayed from all practicable directions. The water pressure was adjusted to give the specified delivery rate. The pressure to achieve this delivery rate was in the range of 50 kPa to 150 kPa, which was kept constant during the test. The test duration was 1 min/m² of the calculated surface area of the DUT enclosure (excluding any mounting surface), with a minimum duration of 5 min.

Dimensions in millimetres
